Repairs Recommended Summary

Inspector Name John Cheney
 License # 4500001239
 Company Name Pristine Inspections, LLC
 Company Address 2204 Barberry Dr.
 City Champaign State IL Zip 61821
 Phone 217-352-3743 Fax 309-279-5720
 E-Mail Pristine@insightbb.com
 File Number 9999
 Amount Received \$305.00
 Payment Method Check Check # 9999

Others Present Client's Agent at Beginning Client 100%
 Estimated Age 8 Years Entrance Faces East Property Occupied Yes
 Inspection Date 07/11/2007
 Start Time 8:20 am End Time 12:05 pm
 Electric On Yes No Not Applicable
 Gas/Oil On Yes No Not Applicable
 Water On Yes No Not Applicable
 Temperature 75 F
 Weather Sunny Soil Conditions Dry
 Space Below Grade Crawl Space
 Building Type Single family Garage Attached
 Sewage Disposal Septic How Verified Owner
 Water Source Shared Well How Verified Owner
 Additions/Modifications N/A

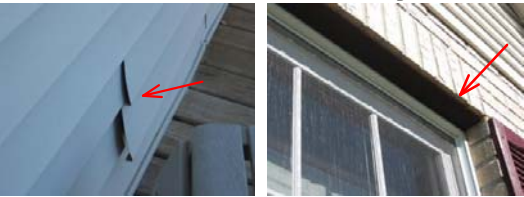
Rusty steel lintels noted. Steel lintels, used above doors and window openings to support the brick on brick walls, should always be protected from the elements with a thorough coat of paint. Failure to maintain the lintels will allow them to rust and expand which will eventually crack the brick and mortar around the lintels. Removal of the existing rust, priming of the steel and painting is recommended.

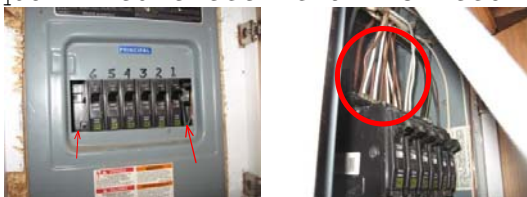
Neutral & ground wires are not separated within the panel box. Electrical sub-panels are supposed to have the neutrals & grounds wires routed to separate buss bars to ensure safe operation of the electrical system. Evaluation and/or repairs by a qualified electrician is recommended.

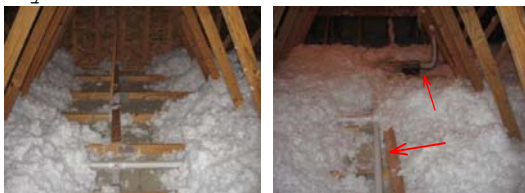
21. **House (Master) Attic Insulation Type: Fiberglass Blown-in** - Loose fill altered. The insulation in the middle of the attic has been pushed to the sides revealing the drywall. The insulation should be redistributed evenly over the entire area.

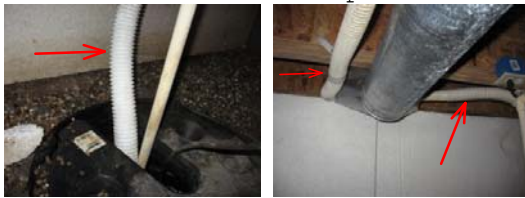
Flexible discharge line observed is inadequate. Flex discharge line is leaking from the flex line above the pump. Flex lines are very susceptible to developing leaks and are considered a poor material for sump pump drain lines located inside a structure. Rigid PVC piping, complete with a check valve, if not already installed, is recommended to replace the existing drain line.

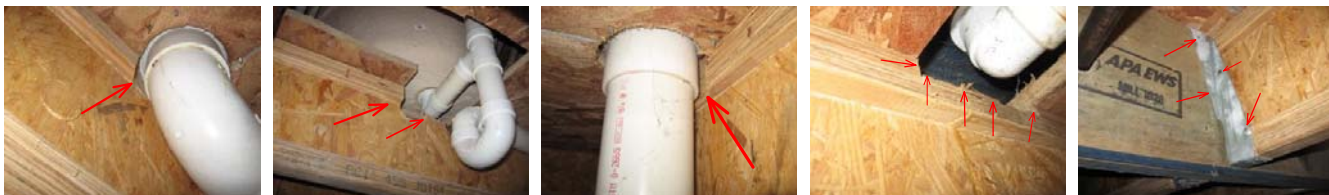
25. **Joists/Trusses:** Wood I-Joists - Modified wood I-joist was observed. There is a notch cut out of a floor joist, and on this type of framing system, no notching is typically permitted per the manufacturer's specifications. I recommend contacting the joist manufacturer for repair specifications per their engineering department. Such specifications should be followed exactly in order to ensure the I-joist is properly repaired.

Joist hangers improperly installed, due to missing nails. Joist hanger installation requires that all nail holes be used to attach the bracket and the joist to the bracket. Repairs are recommended.

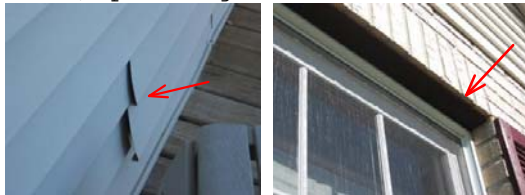
Rusty steel lintels noted. Steel lintels, used above doors and window openings to support the brick on brick walls, should always be protected from the elements with a thorough coat of paint. Failure to maintain the lintels will allow them to rust and expand which will eventually crack the brick and mortar around the lintels. Removal of the existing rust, priming of the steel and painting is recommended.

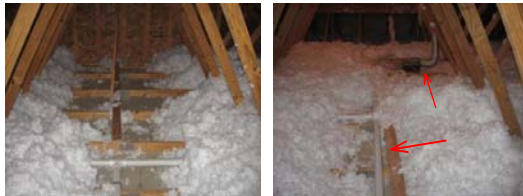
1. Method of Inspection: Walked Through the Attic
2. Unable to Completely Inspect:
3. Access: Wood Panel
4. Access Location: Master Bedroom Closet
5. Roof Framing: 2x4 Truss, 2x6 Rafter
6. Sheathing: Oriented Strand Board (OSB)
7. Ventilation: Ridge and Soffit Vents
8. Insulation Type: Fiberglass Blown-in - Loose fill altered. The insulation in the middle of the attic has been pushed to the sides revealing the drywall. The insulation should be redistributed evenly over the entire area.

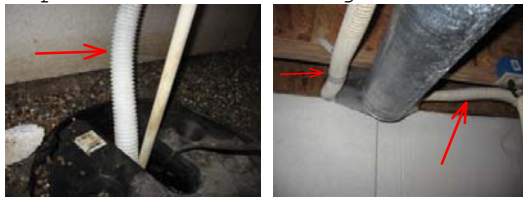
Flexible discharge line observed is inadequate. Flex discharge line is leaking from the flex line above the pump. Flex lines are very susceptible to developing leaks and are considered a poor material for sump pump drain lines located inside a structure. Rigid PVC piping, complete with a check valve, if not already installed, is recommended to replace the existing drain line.

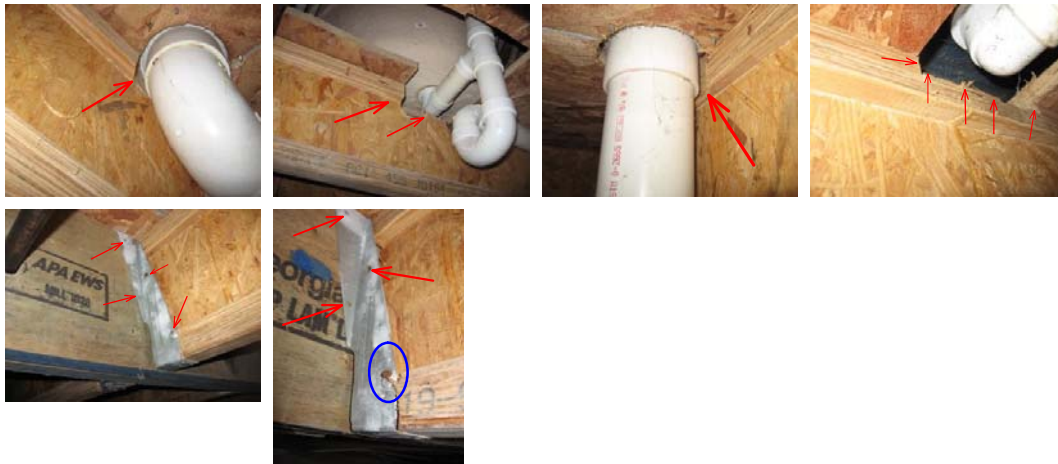
- 1. **Structure Type:** Wood Frame
- 2. **Foundation:** Cement Block
- 3. **Bearing Walls:** Block
- 4. **Joists/Trusses:** Wood I-Joists - Modified wood I-joist was observed. There is a notch cut out of a floor joist, and on this type of framing system, no notching is typically permitted per the manufacturer's specifications. I recommend contacting the joist manufacturer for repair specifications per their engineering department. Such specifications should be followed exactly in order to ensure the I-joist is properly repaired.

Joist hangers improperly installed, due to missing nails. Joist hanger installation requires that all nail holes be used to attach the bracket and the joist to the bracket. Repairs are recommended.
