Home Inspection Report

123 Any Street
Any Town, IL 99999

Inspected by: John Cheney, ACI

Pristine
Inspections & Testing

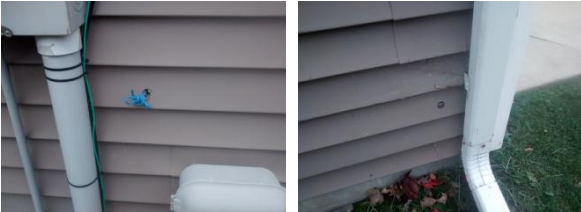
2. **House & Garage Exterior Surface Type:** Vinyl Siding - Small holes have been drilled in the siding on the east side of the garage. Sealing these holes is recommended.

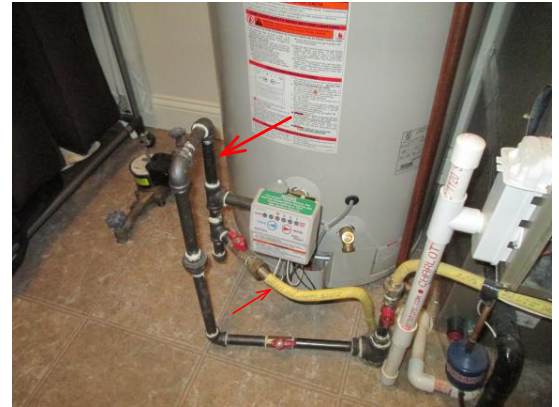
7. **Gas Service Lines:** Black Iron, Flex Gas Line (CSST-Corrugated Stainless Steel Tubing) - Gas line may not be large enough for the number of appliances, water heater and fireplace, it is supplying. The gas line shall provide sufficient gas to meet the maximum demand of the gas equipment. Sizing is based on the BTU's of the units and the length of the pipe transporting the gas. Piping must be sized to supply enough fuel for all appliances to operate at the same time.

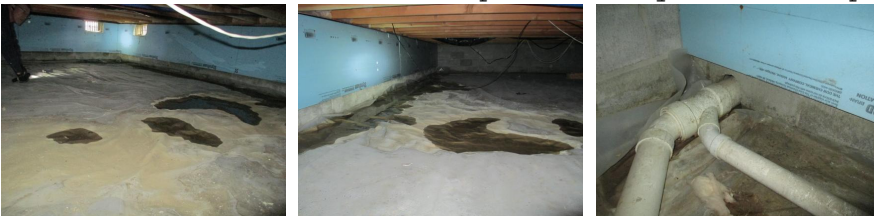
A gap noted around the main sanitary line as it exits the structure. It appears that ground water may be entering the crawl space in this area as well. This should be sealed to eliminate the possibility of water penetration.

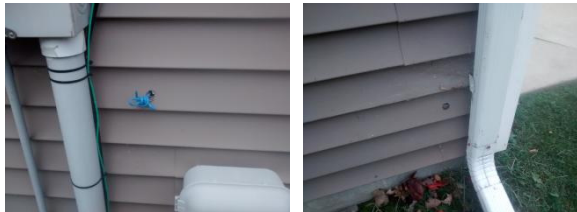
1. **Type:** Vinyl Siding - Small holes have been drilled in the siding on the east side of the garage. Sealing these holes is recommended.

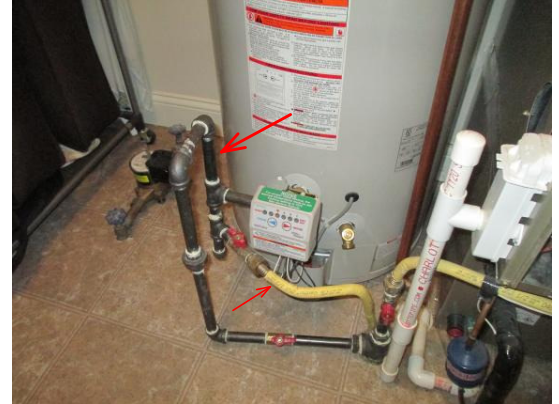
- 1. **Service Line:** Plastic
- 2. **Main Water Shutoff:** Laundry Room
- 3. **Water Lines:** Copper, Polyethylene (PEX)
- 4. **Drain Pipes:** PVC
- 5. **Service Caps:** Observed
- 6. **Gas Service Lines:** Black Iron, Flex Gas Line (CSST-Corrugated Stainless Steel Tubing) - Gas line may not not large enough for the number of appliances, water heater and fireplace, it is supplying. The gas line shall provide sufficient gas to meet the maximum demand of the gas equipment. Sizing is based on the BTU's of the units and the length of the pipe transporting the gas. Piping must be sized to supply enough fuel for all appliances to operate at the same time.

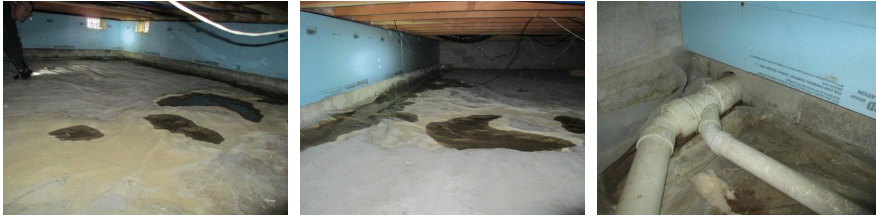
A gap noted around the main sanitary line as it exits the structure. It appears that ground water may be entering the crawl space in this area as well. This should be sealed to eliminate the possibility of water penetration.
