# Home Inspection Report

Inspection Date: 10/20/2016

123 Any Street  
Any Town, IL 12345

*Pristine*  
Inspections & Testing

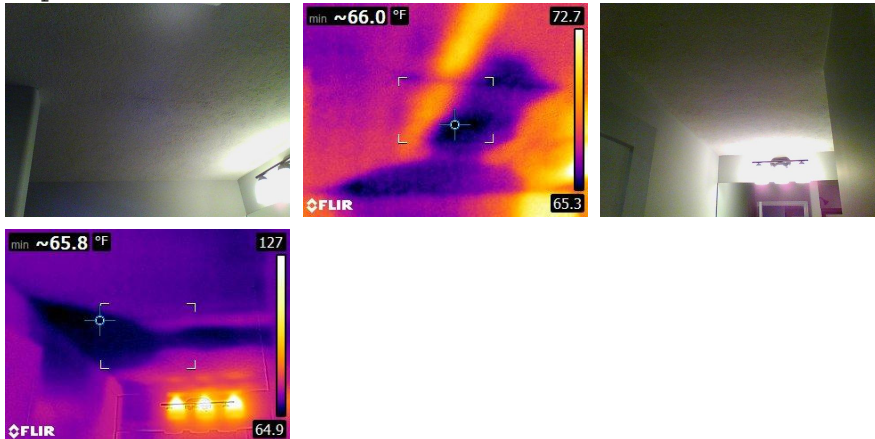
1. ☐ ☒ ☐ ☐ ☐ ☐ ☐ **Ceiling:** Drywall, Exposed Framing - Stains were not observed on the ceiling under the master shower but infrared identified a sign of moisture and it was tested with my moisture meter. Repairs are needed to correct the moisture condition/water leak. Once the water source is corrected, the ceiling surface will need to be repaired.
