Home Inspection Report

Inspection Date: 10/20/2016

123 Any Street
Any Town, IL 12345

Pristine
Inspections & Testing

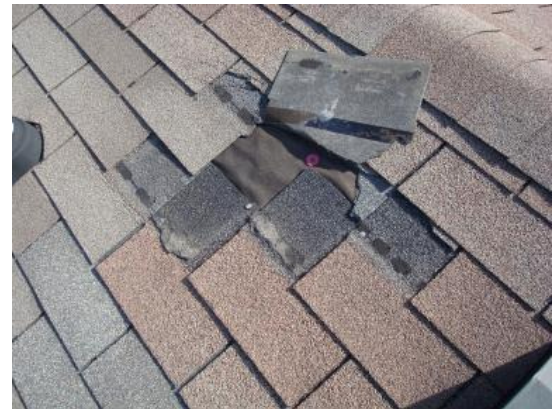
5. **House & Garage Roof Surface Material:** Composition Shingles - Missing and damaged shingles noted. Repairs are recommended to correct this condition. Failure to properly replace the missing tab can result in a roof leak.

Replacement shingles installed in areas on the roof.

Roof shows signs of deterioration and aging.

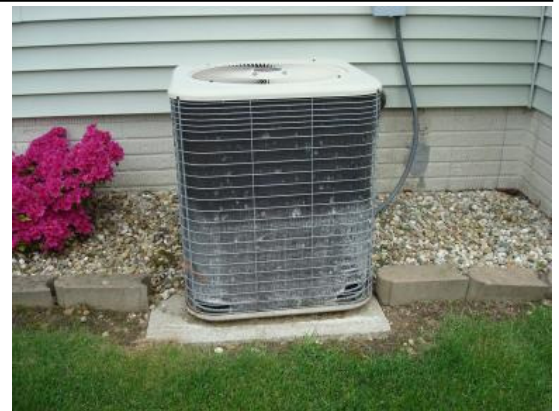
8. **North, East AC System External Condenser Unit: Damaged Fins** Observed - Damage was observed on the cooling fins due to animal urine. The acid has deteriorated the metal fins and will eventually create a leak in the copper tube which holds the refrigerant. The extent of the damage can not be determined at this time due to the continuing deterioration even in the absence of the animal. The damage will effect the efficiency of the unit and the only remedy is a new unit. The unit should be monitored and replaced on an as needed basis.

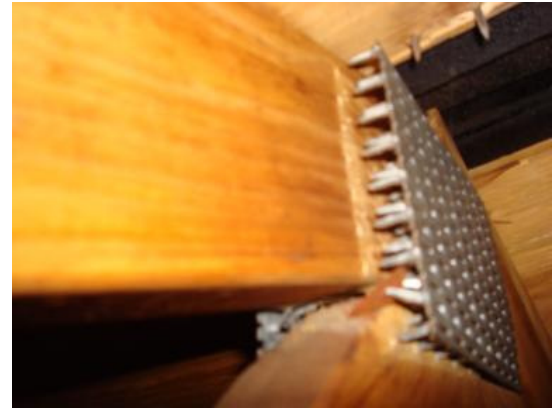
18. House & Garage Attic Roof Framing: 2x4 Truss, 2x6 Rafter - Loose gusset plate noted on a truss. Repairs are recommended to ensure the stability of the engineered truss. Repairs are recommended by a qualified carpenter.

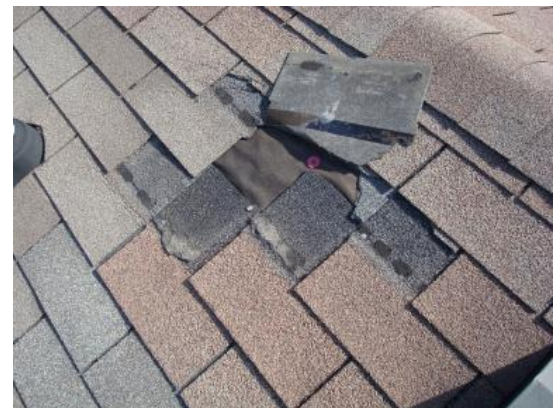
3. ☐ ☒ ☐ ☐ ☐ ☐ ☐ **Material:** Composition Shingles - Missing and damaged shingles noted. Repairs are recommended to correct this condition. Failure to properly replace the missing tab can result in a roof leak.

Replacement shingles installed in areas on the roof.

Roof shows signs of deterioration and aging.

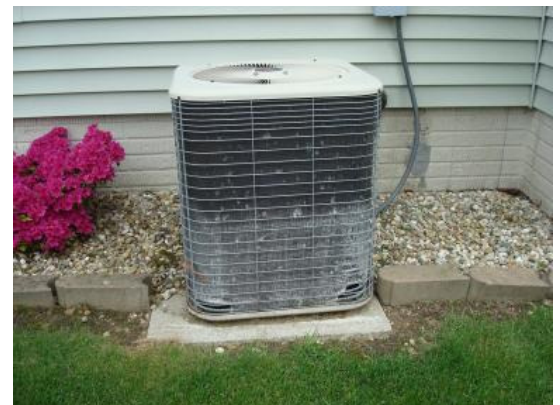
1. ☐ ☐ ☐ ☐ ☐ ☐ ☒ **Operation:** Too Cool To Test
2. ☐ ☐ ☐ ☐ ☐ ☐ ☒ **Exterior Unit:** Trane
3. **Type:** Central A/C **Capacity:** 3.5 Ton
4. **Area Served:** Entire House **Approximate Age:** 11 Years
5. **Fuel Type:** 240 **Temperature Differential:** N/A
6. ☐ ☒ ☐ ☐ ☐ ☐ ☐ ☐ **External Condenser Unit:** Damaged Fins Observed - Damage was observed on the cooling fins due to animal urine. The acid has deteriorated the metal fins and will eventually create a leak in the copper tube which holds the refrigerant. The extent of the damage can not be determined at this time due to the continuing deterioration even in the absence of the animal. The damage will effect the efficiency of the unit and the only remedy is a new unit. The unit should be

monitored and replaced on an as needed basis.

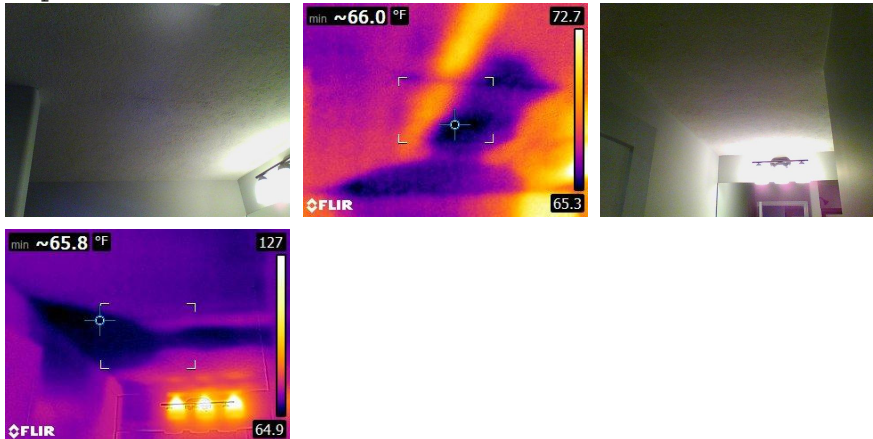
1. ☐ ☒ ☐ ☐ ☐ ☐ ☐ **Ceiling:** Drywall, Exposed Framing - Stains were not observed on the ceiling under the master shower but infrared identified a sign of moisture and it was tested with my moisture meter. Repairs are needed to correct the moisture condition/water leak. Once the water source is corrected, the ceiling surface will need to be repaired.

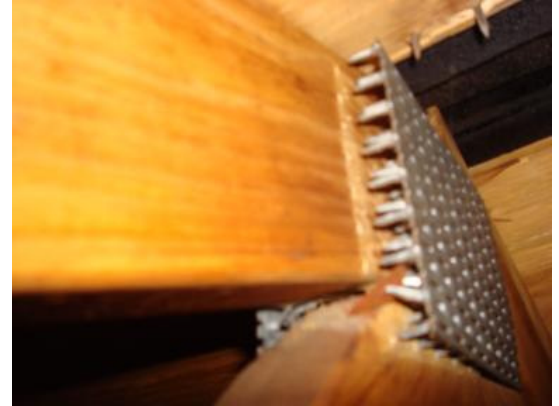
4. ☐ ☒ ☐ ☐ ☐ ☐ ☐ **Roof Framing:** 2x4 Truss, 2x6 Rafter - Loose gusset plate noted on a truss. Repairs are recommended to ensure the stability of the engineered truss. Repairs are recommended by a qualified carpenter.

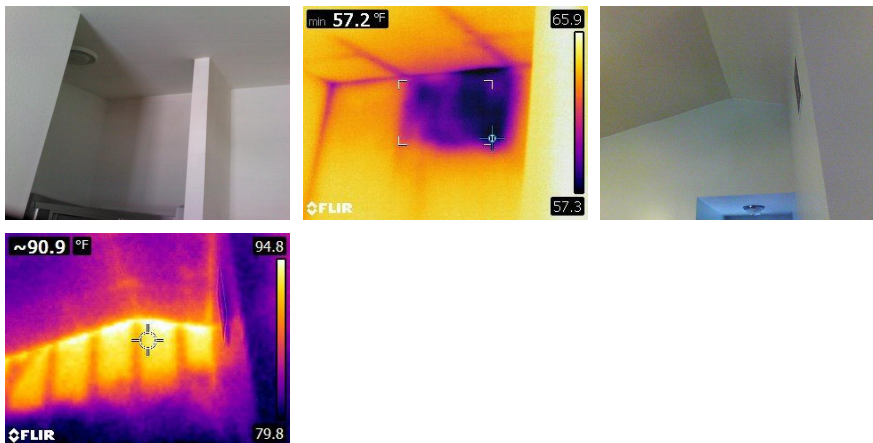
5. ☒ ☐ ☐ ☐ ☐ ☐ ☐ **Sheathing:** Oriented Strand Board (OSB)
 6. ☒ ☐ ☐ ☐ ☐ ☐ ☐ **Ventilation:** Roof and Soffit Vents
 7. ☐ ☒ ☐ ☐ ☐ ☐ ☐ **Insulation Type:** Fiberglass Blown-in - Missing/moved insulation on a wall area. Repairs are recommended to keep the house properly insulated.

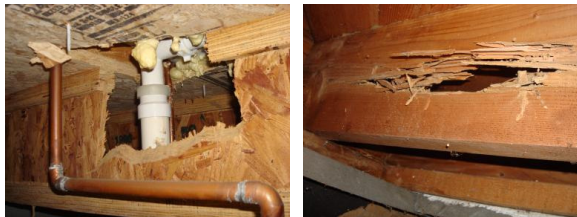
2. ☒ ☐ ☐ ☐ ☐ ☐ ☐ **Structure Type:** Wood Frame
3. ☒ ☐ ☐ ☐ ☐ ☐ ☐ **Foundation:** Poured Concrete
4. ☒ ☐ ☐ ☐ ☐ ☐ ☐ **Beams:** Laminated Wood
5. ☒ ☐ ☐ ☐ ☐ ☐ ☐ **Piers/Posts:** Steel Posts
6. ☐ ☒ ☐ ☐ ☐ ☐ ☐ **Joists/Trusses:** Wood I-Joists, 2x10 Wood - Modified wood I-joist was observed. There is a notch cut out of a floor joist, and on this type of framing system, no notching is typically permitted per the manufacturer's specifications. I recommend contacting the joist manufacturer for repair specifications per their engineering department. Such specifications should be followed exactly in order to ensure the I-joist is properly repaired.

Insect damaged wood was observed. Wood repairs may be needed, so a qualified carpenter should evaluate this damage and make repairs as needed.
